Manhole Inspection Summary

Manhole # S45MM_052MH

Insp Date: **3/25/08 9:08 AM**

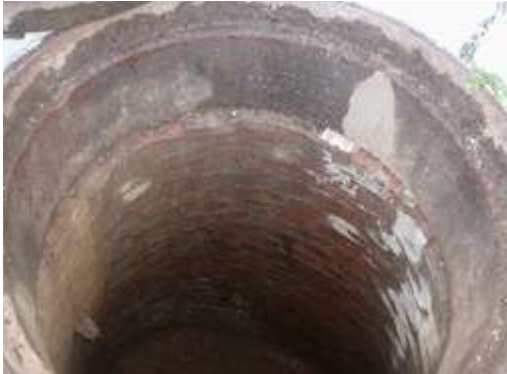
Defect 2

☒ **Leaks**

Frame Leaks

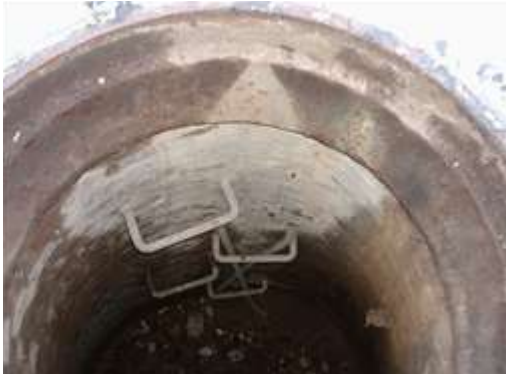
Defect 1

Infiltration: ☐ None ☐ Joint ☐ Cracks ☒ **Mortar** ☐ Roots ☒ **Wall**

Adjustment Joint

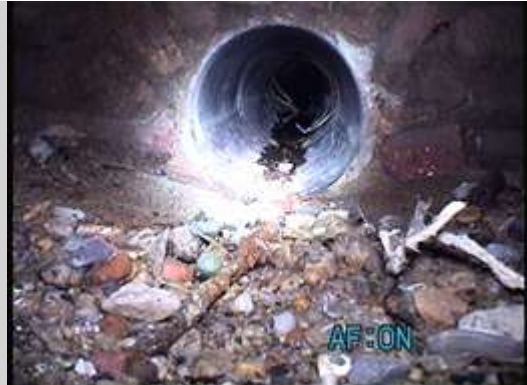
12 O'Clock Outflow

8 in. Circular Gravity Sewer
Pipe Out @ 12 O'Clock

Deposits: ☐ None ☐ Mud ☐ Sludge ☒ **Debris** ☐ Grease

Silt Depth: **1** (in.) Deposits Extent: **Light**
